# Intel® Pentium® 4 Processor

## Specification Update

*November 2003*

Document Number: 249199-043

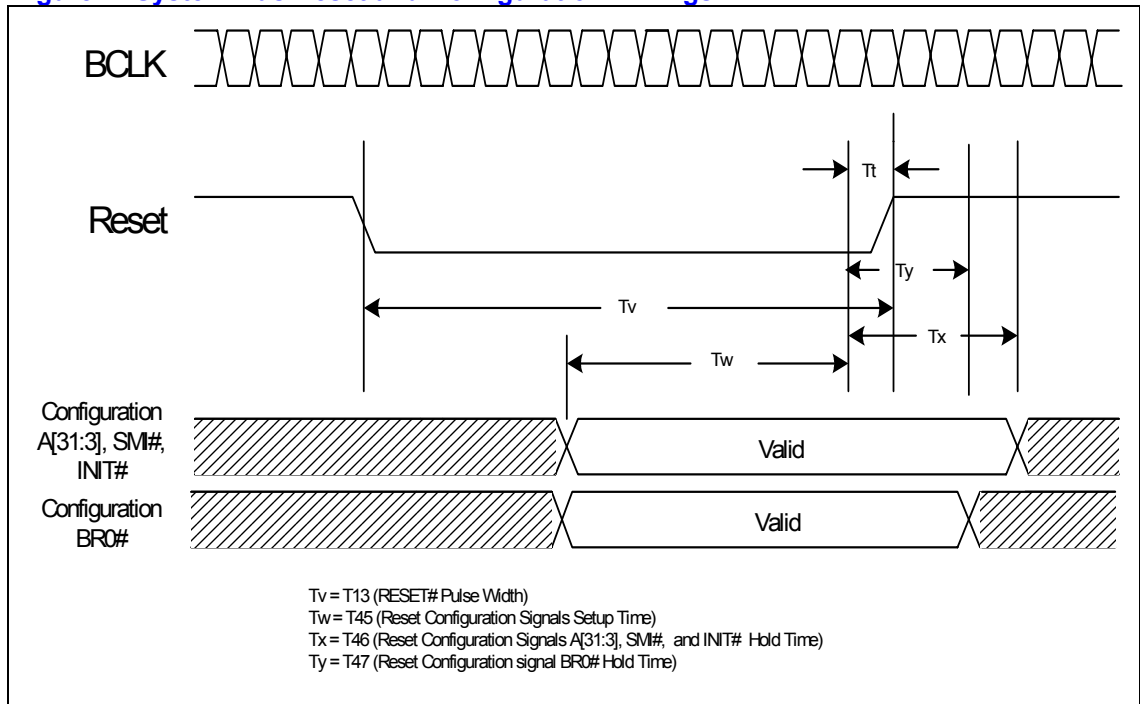
**Figure System Bus Reset and Configuration Timings**

The BR0# maximum hold time has changed to 2 BCLKs. This change will be shown in the “System Bus AC Specifications (Reset Conditions)” table and “System Bus Reset and Configuration Timings” figure of the Intel(R) Pentium(R) 4 Processor with 512KB L2 Cache on 0.13 Micron Process EMTS & Intel(R) Pentium(R) 4 Processor in the 478-pin Package Electrical, Mechanical, and Thermal Specifications (EMTS) & Intel(R) Pentium(R) 4 Processor in the 423-pin Package Electrical, Mechanical, and Thermal Specifications (EMTS). These changes will be incorporated in the next revision of the EMTS (Datasheet).
